## CITY OF ST. HELENS CONTAMINATED MEDIA MANAGEMENT PLAN

400 SOUTH 1<sup>ST</sup> STREET  
ST. HELENS, OREGON  
ECSI NO. 3283

PREPARED FOR  
**CITY OF ST. HELENS**  
JUNE 18, 2015  
PROJECT NO. 0830.01.01

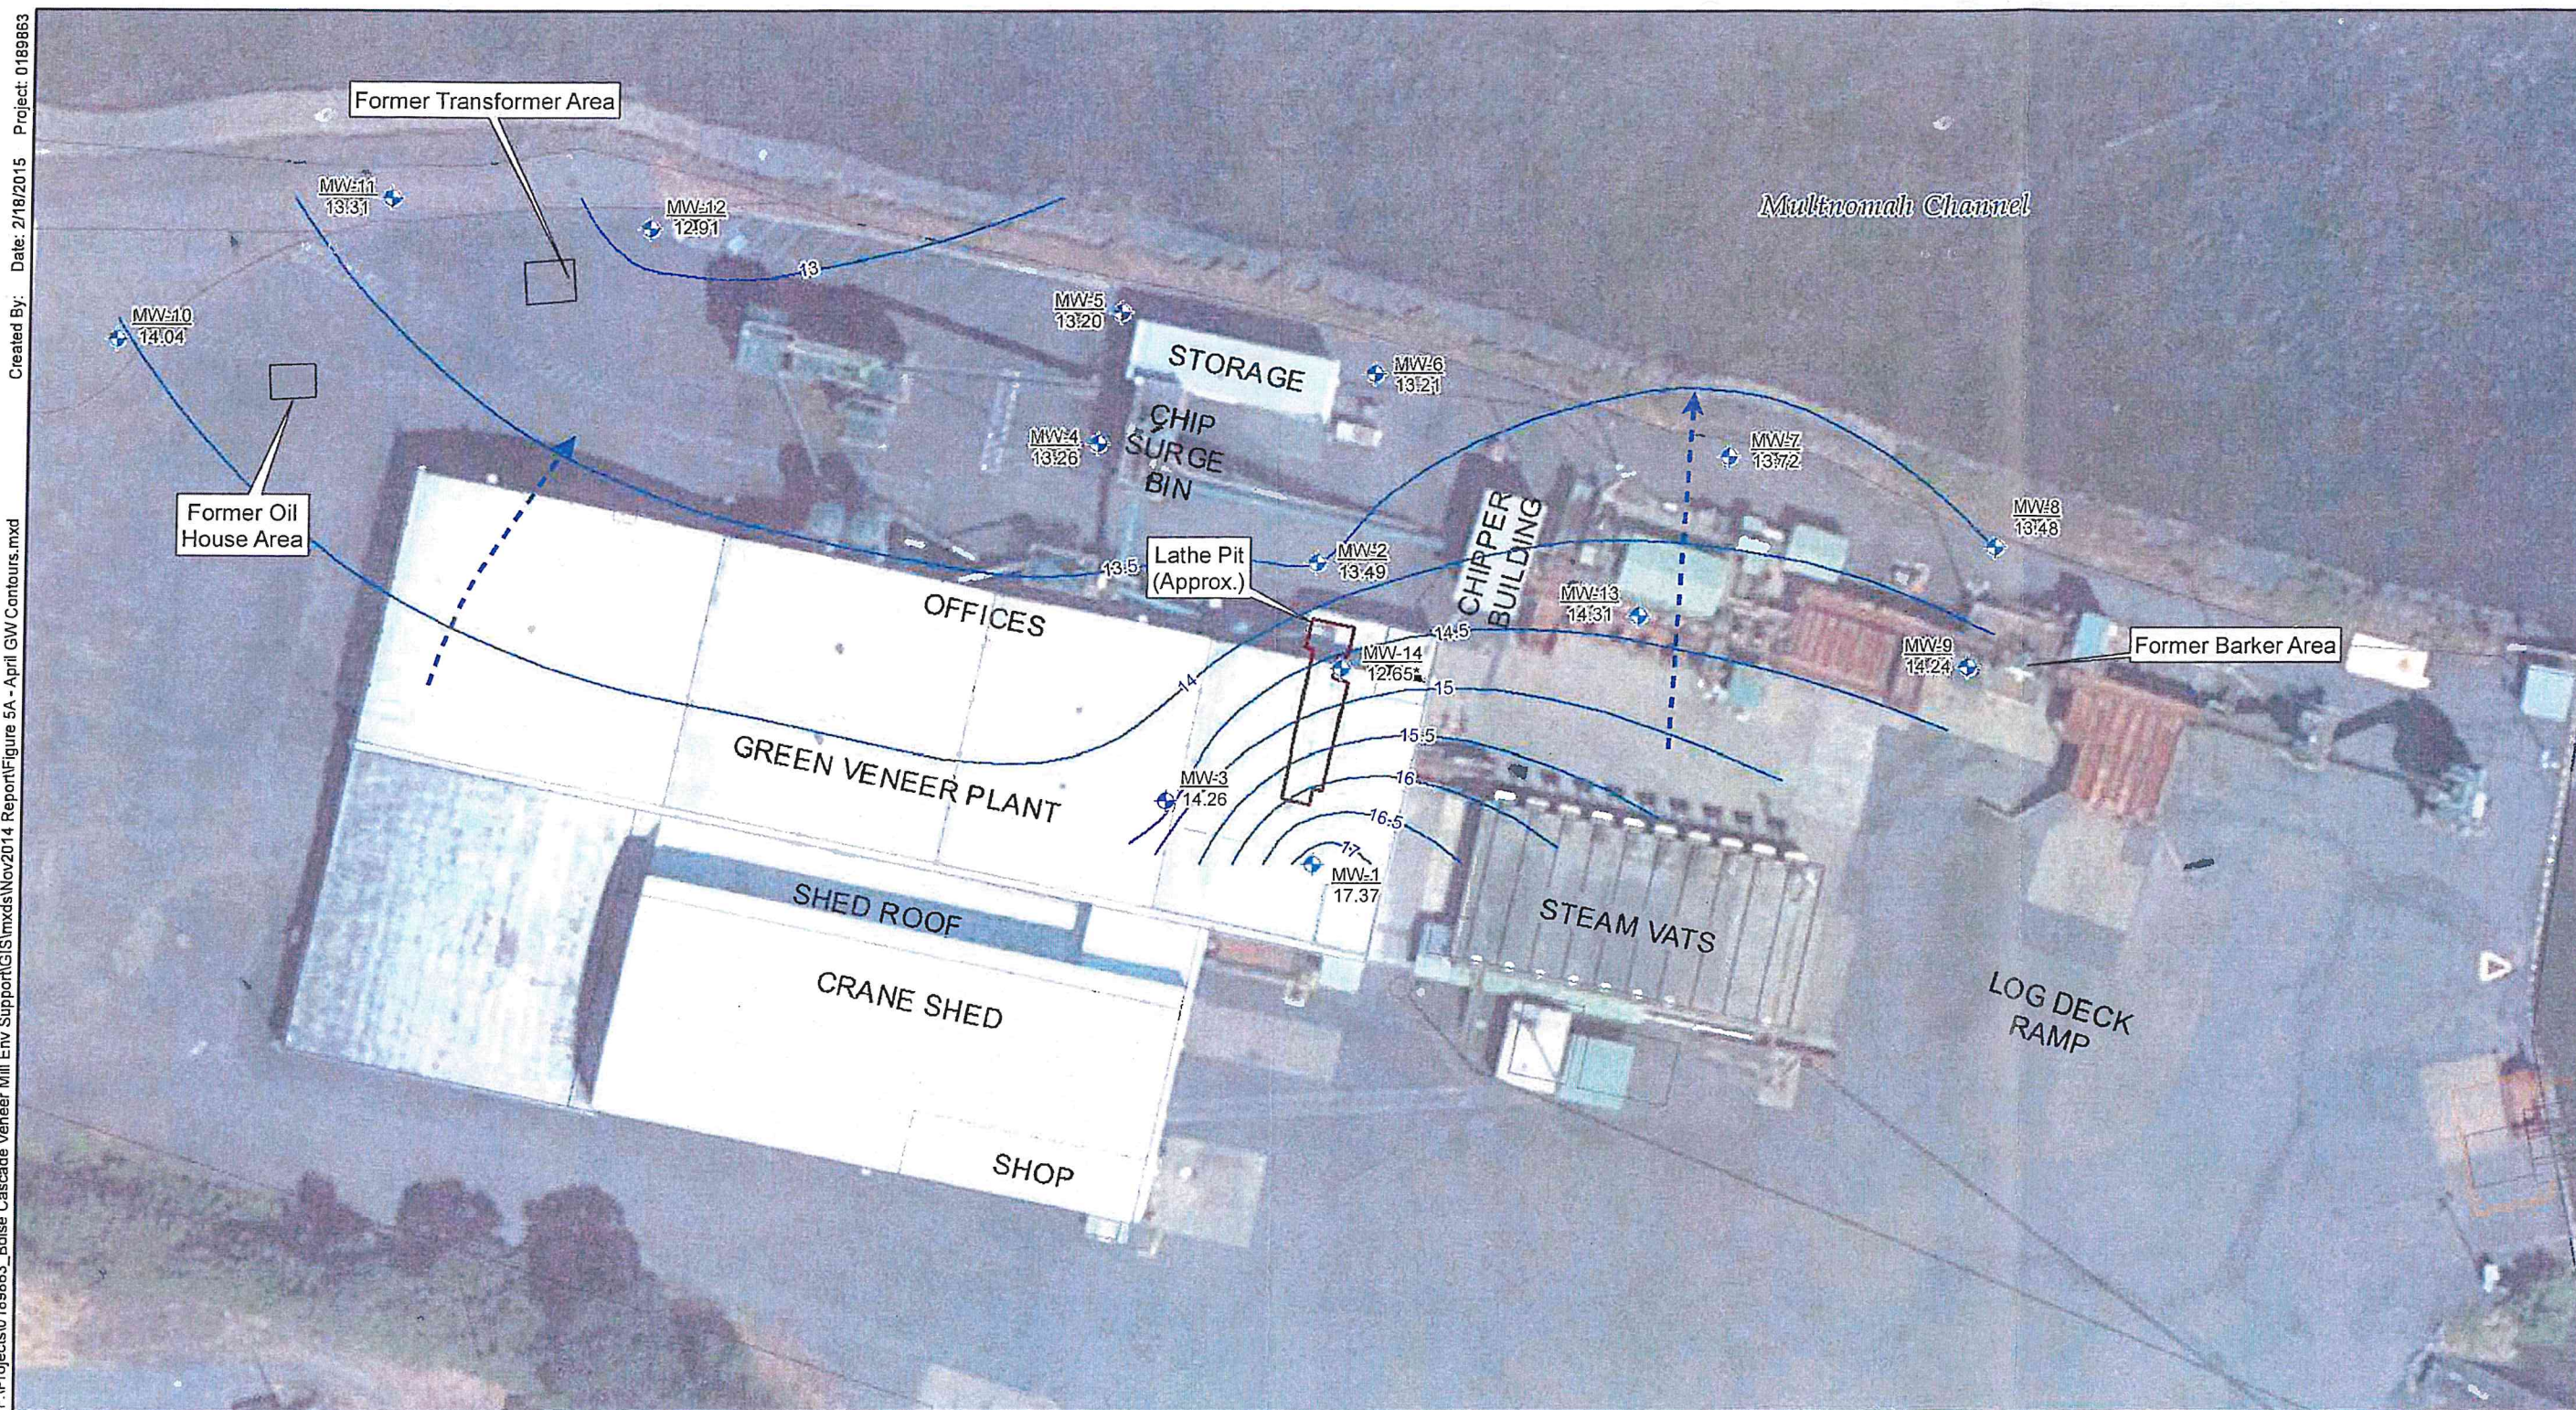
**Figure 5A**  
Groundwater Contours April 3, 2014  
St. Helens Veneer Mill  
St. Helens, Oregon

- Monitoring Well (March 2014)
- Lathe Pit Boundary (Approximate)
- Groundwater Contour (0.5 ft)
- Groundwater Flow Direction

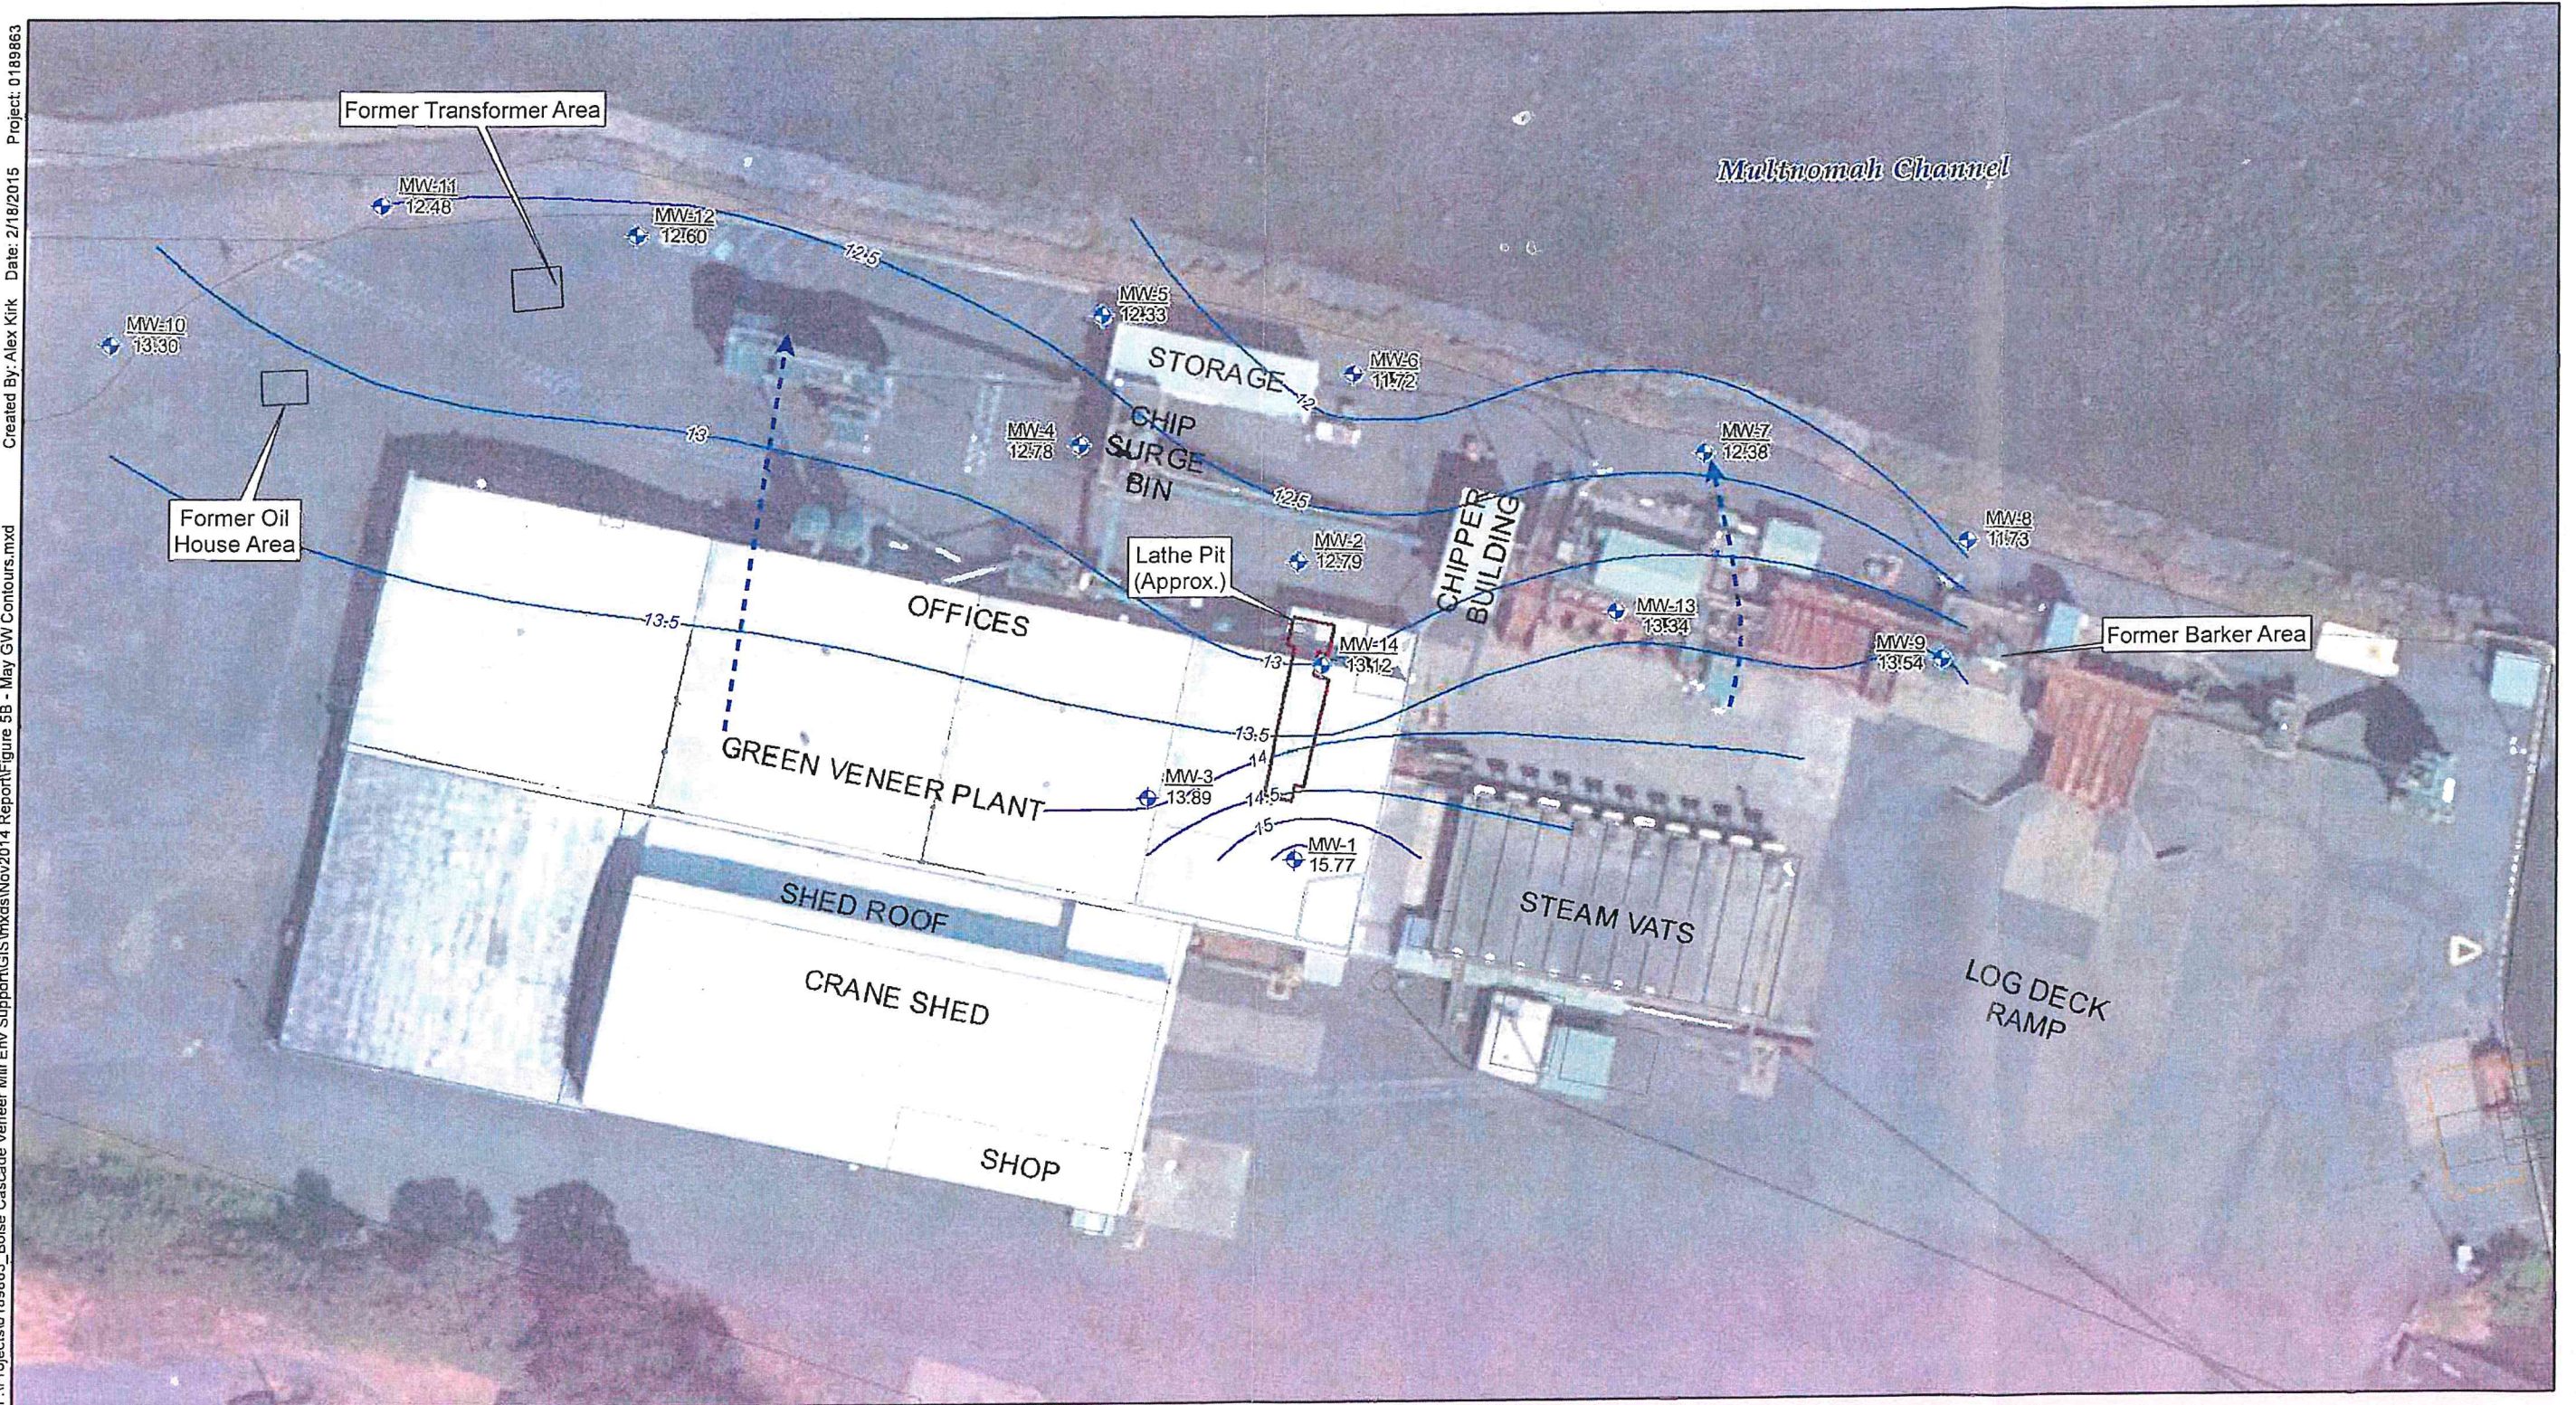
**Figure 5B**  
Groundwater Contours for May 9, 2014  
St. Helens Veneer Mill  
St. Helens, Oregon

- ⊕ Monitoring Well (March 2014)
- Lathe Pit Boundary (Approximate)
- Groundwater Contour (0.5 ft)
- ➔ Groundwater Flow Direction

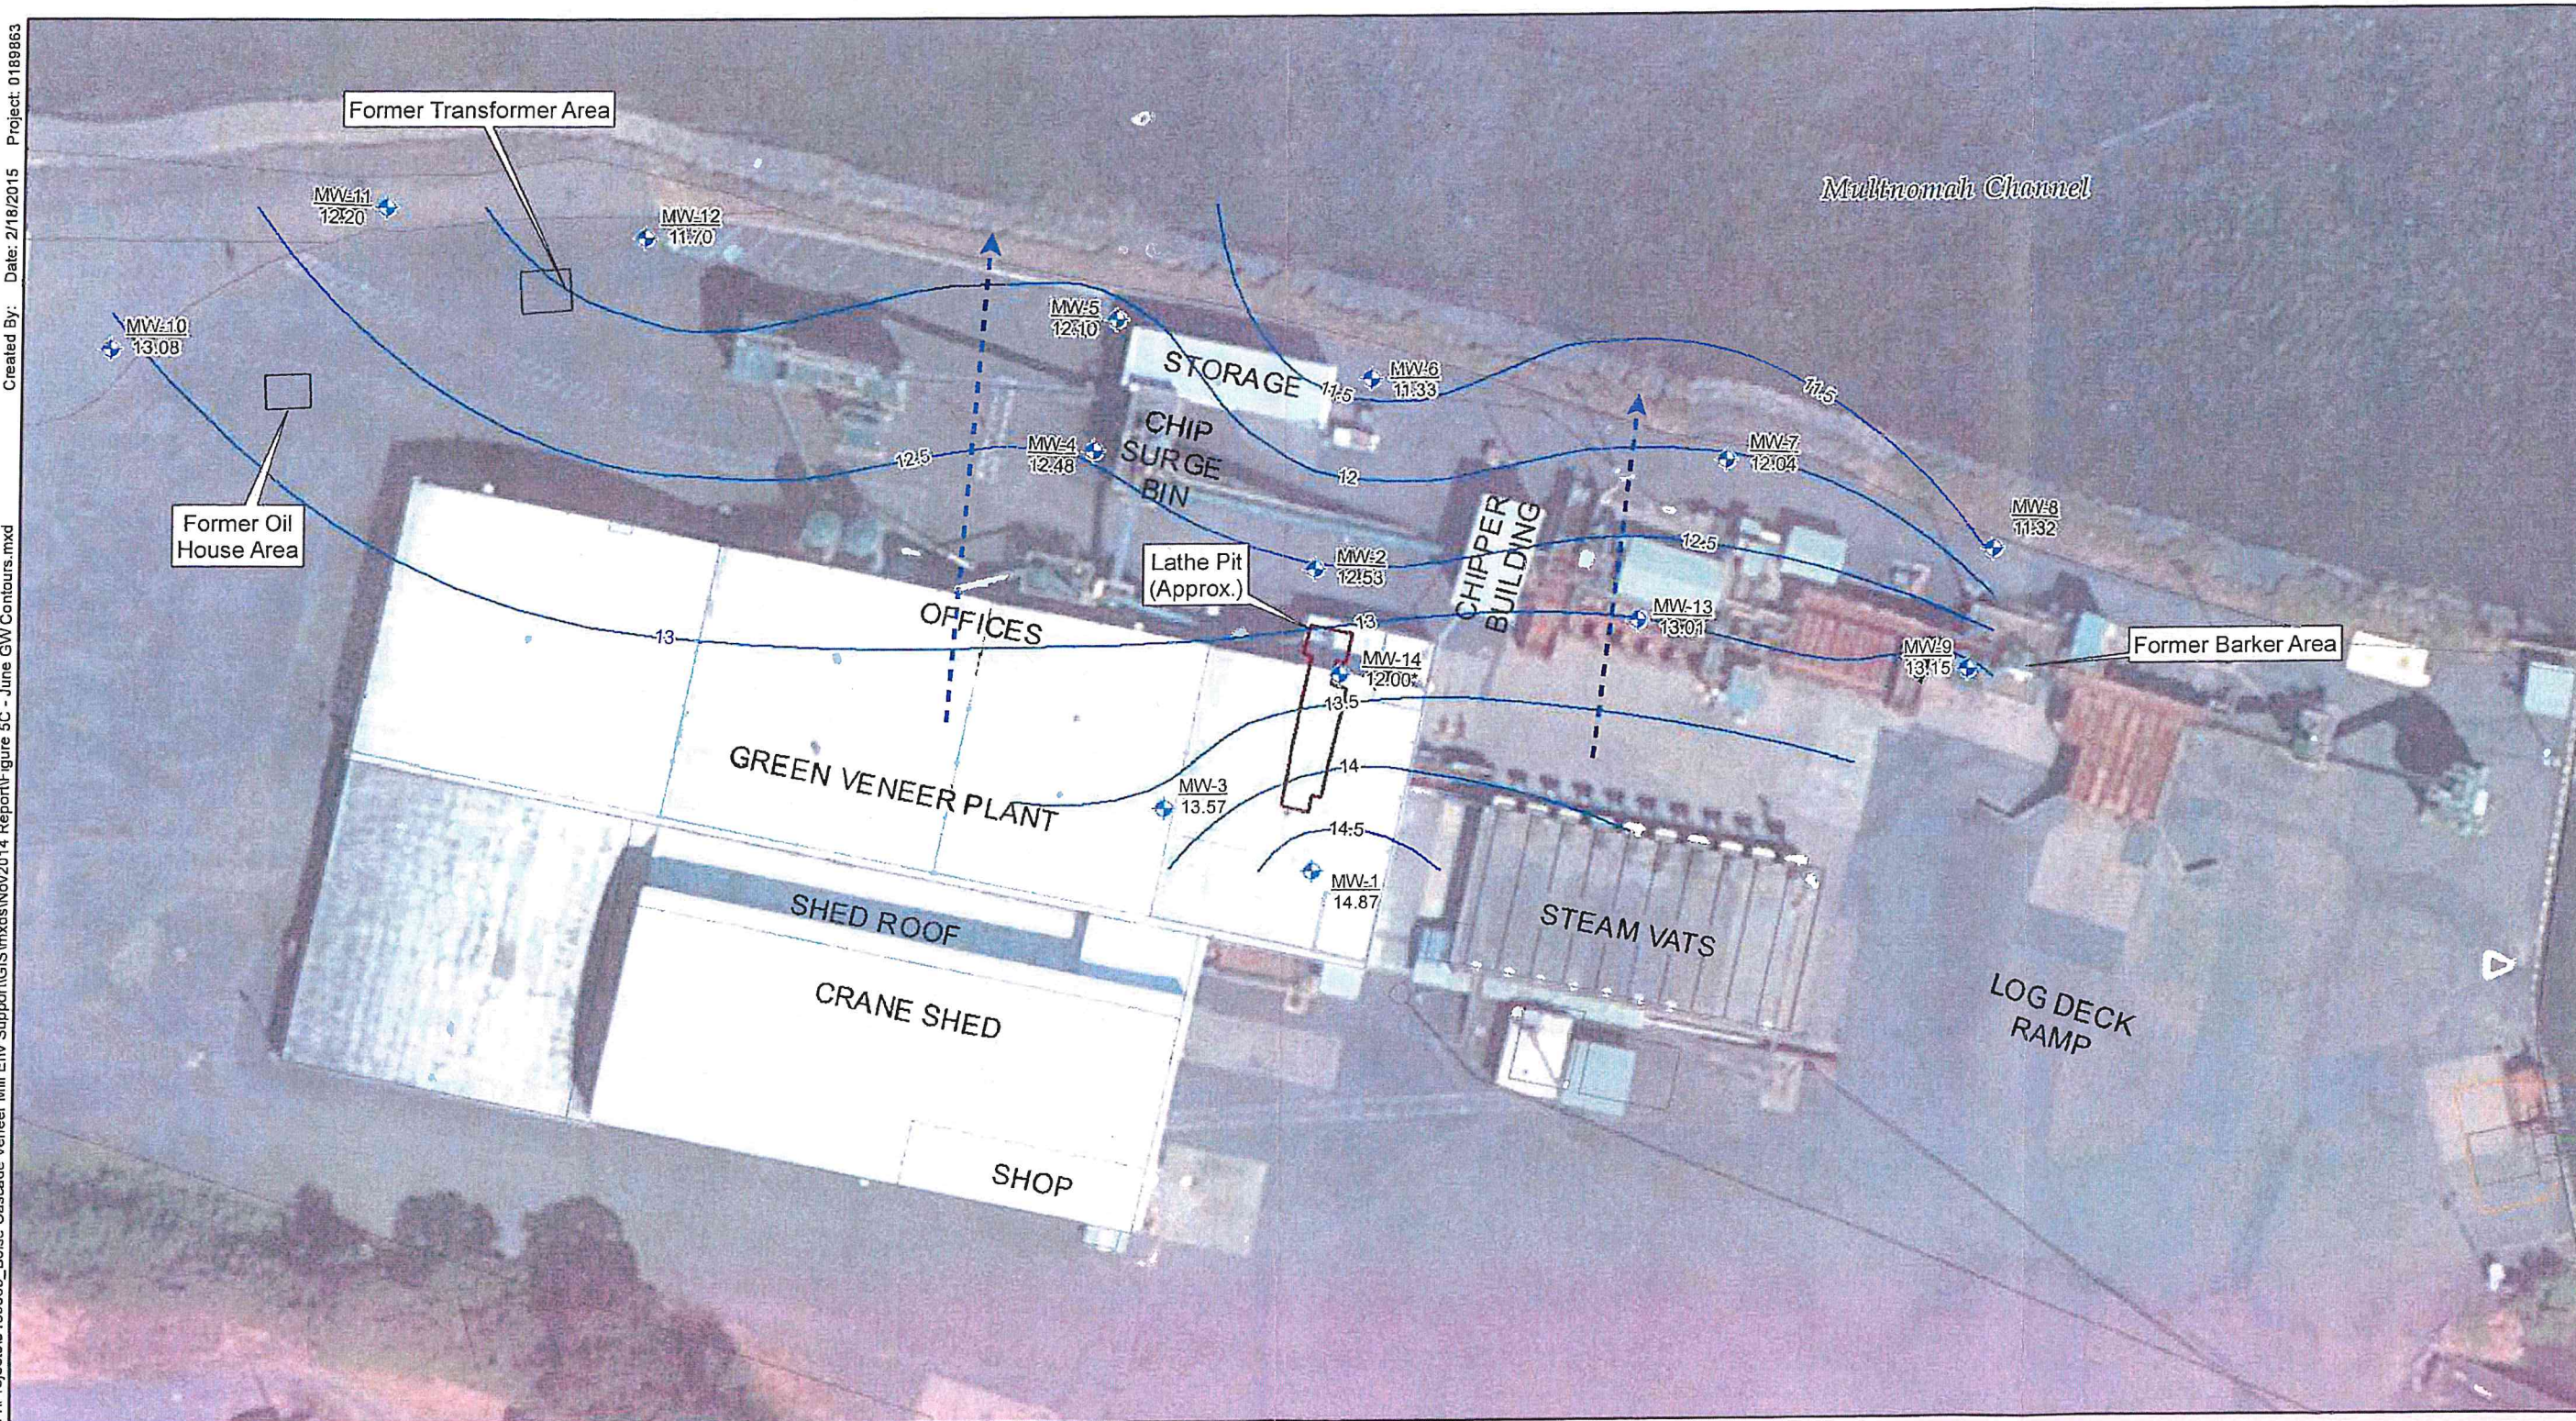
**Figure 5C**  
 Groundwater Contours June 12, 2014  
 St. Helens Veneer Mill  
 St. Helens, Oregon

- ◆ Monitoring Well (March 2014)
- Lathe Pit Boundary (Approximate)
- Groundwater Contour (0.5 ft)
- > Groundwater Flow Direction

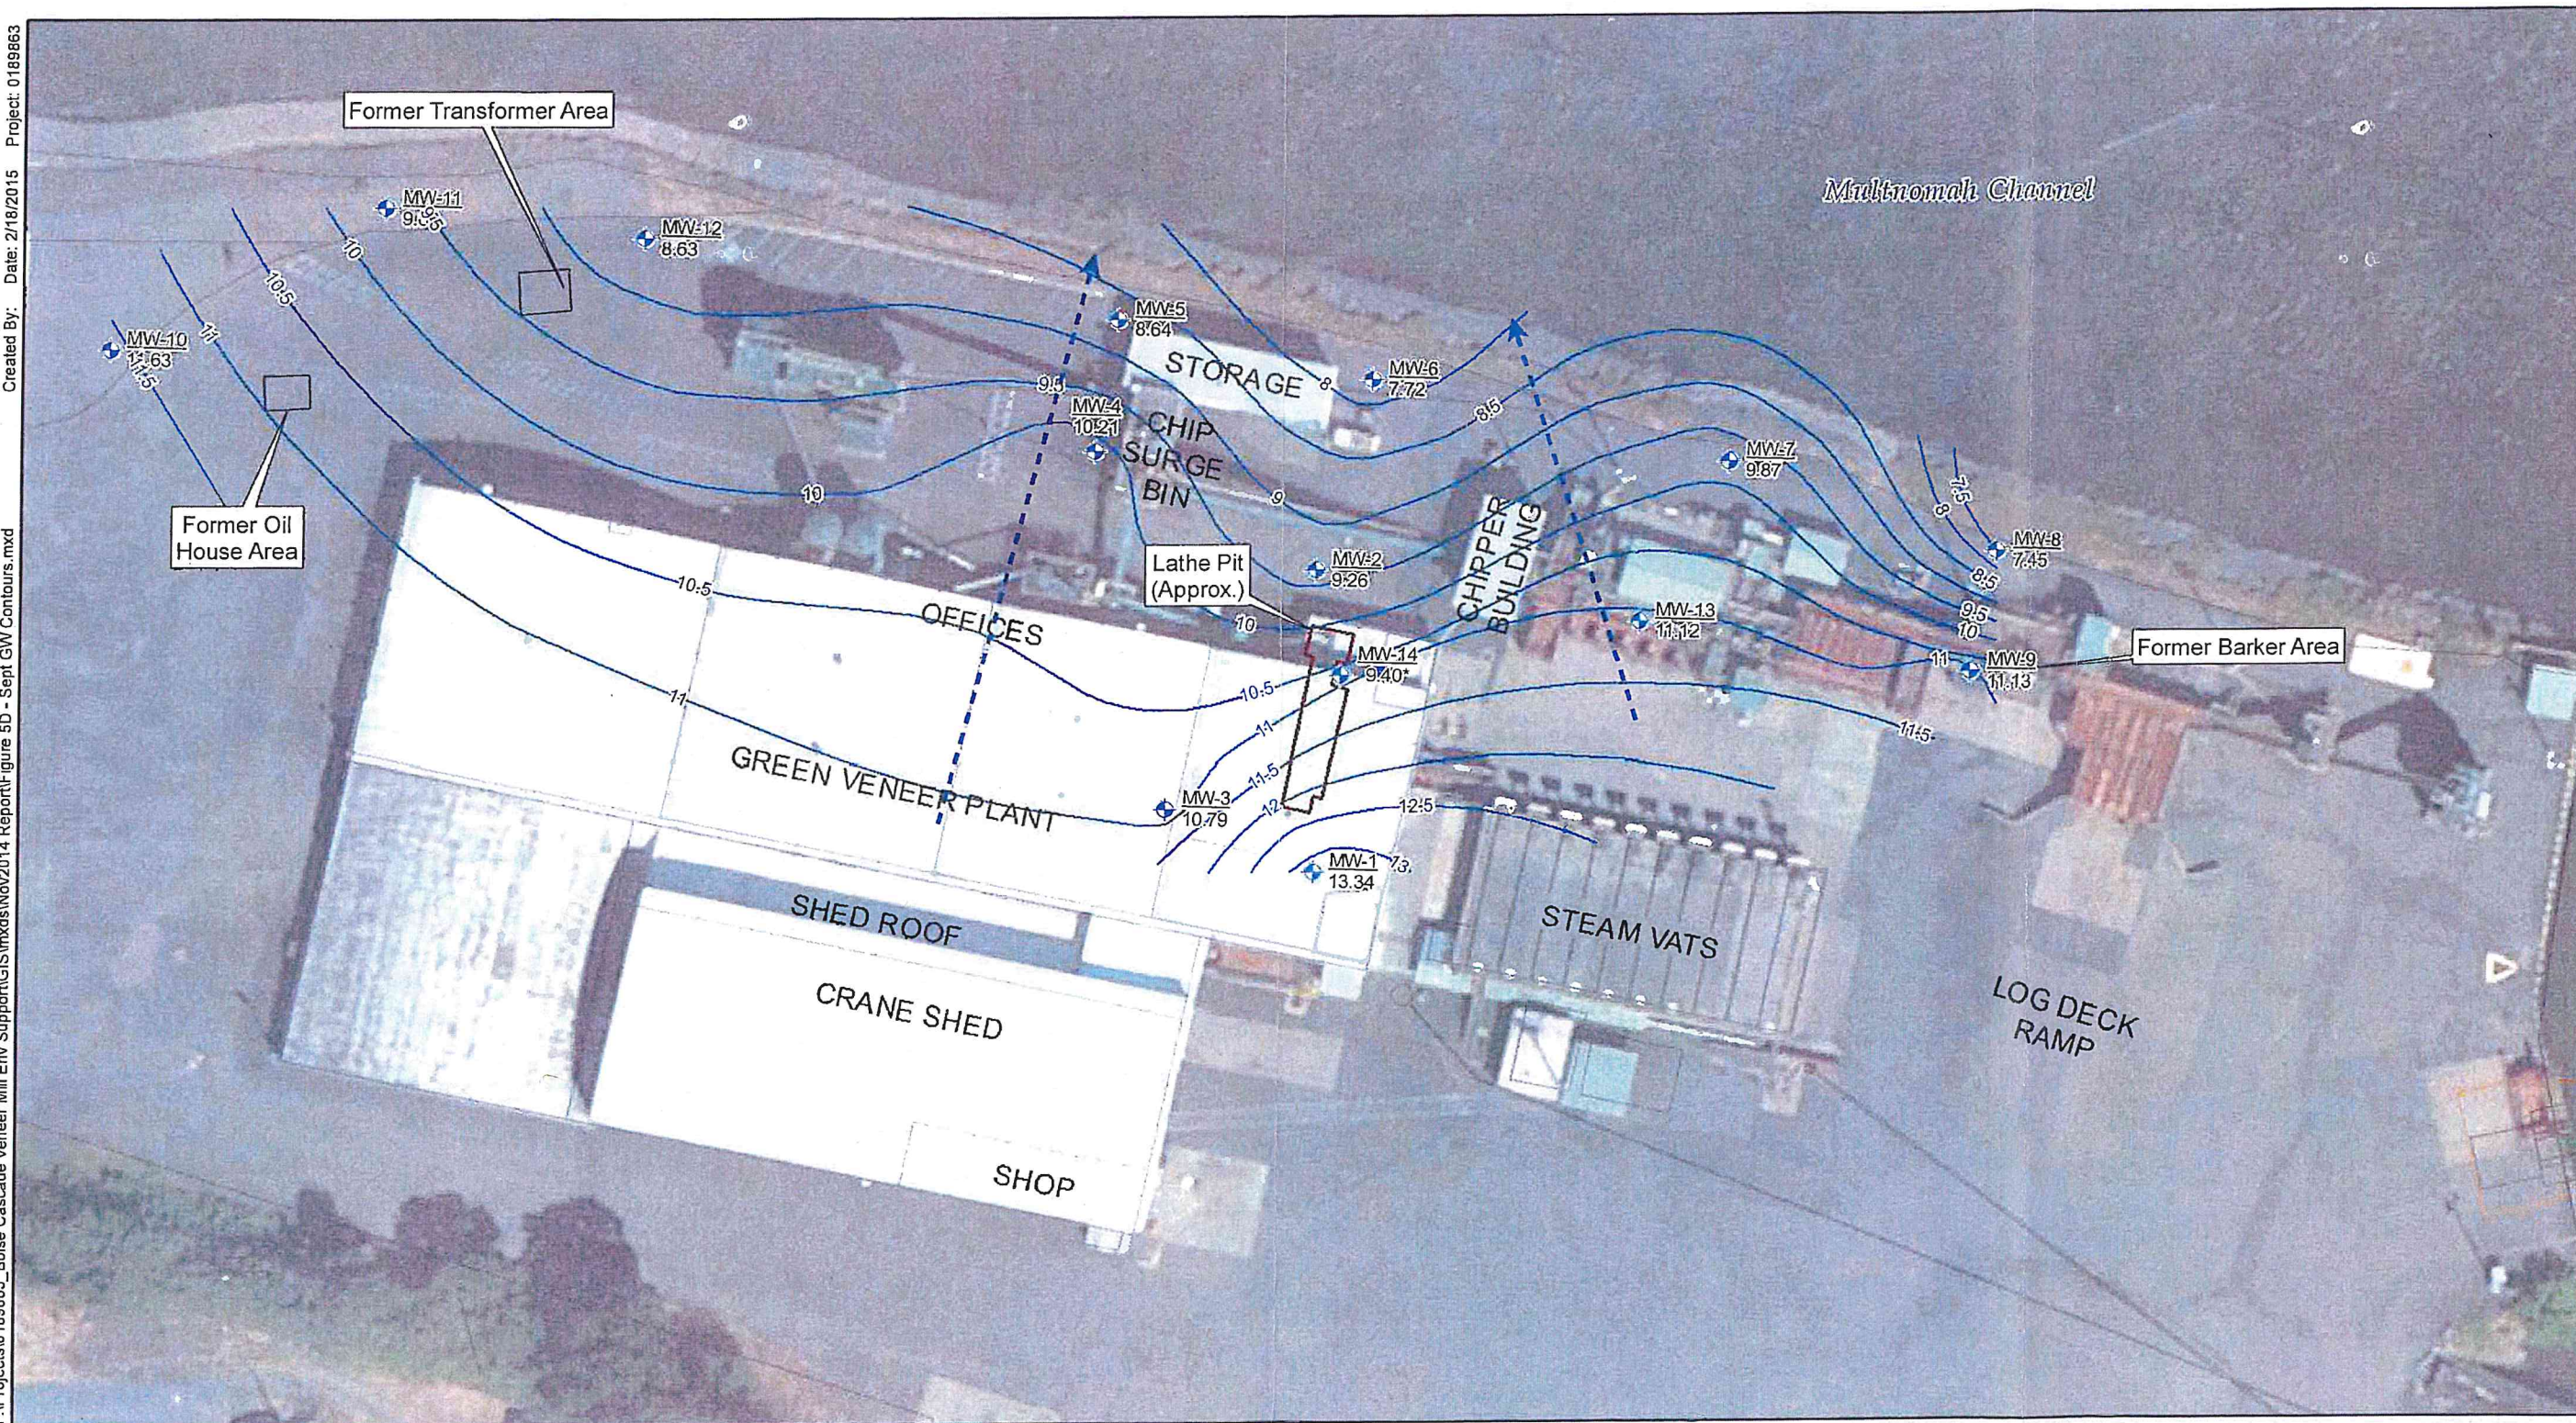
**Figure 5D**  
Groundwater Contours Sept. 24, 2014  
St. Helens Veneer Mill  
St. Helens, Oregon

- Monitoring Well (March 2014)
- Lathe Pit Boundary (Approximate)
- Groundwater Contour (0.5 ft)
- Groundwater Flow Direction

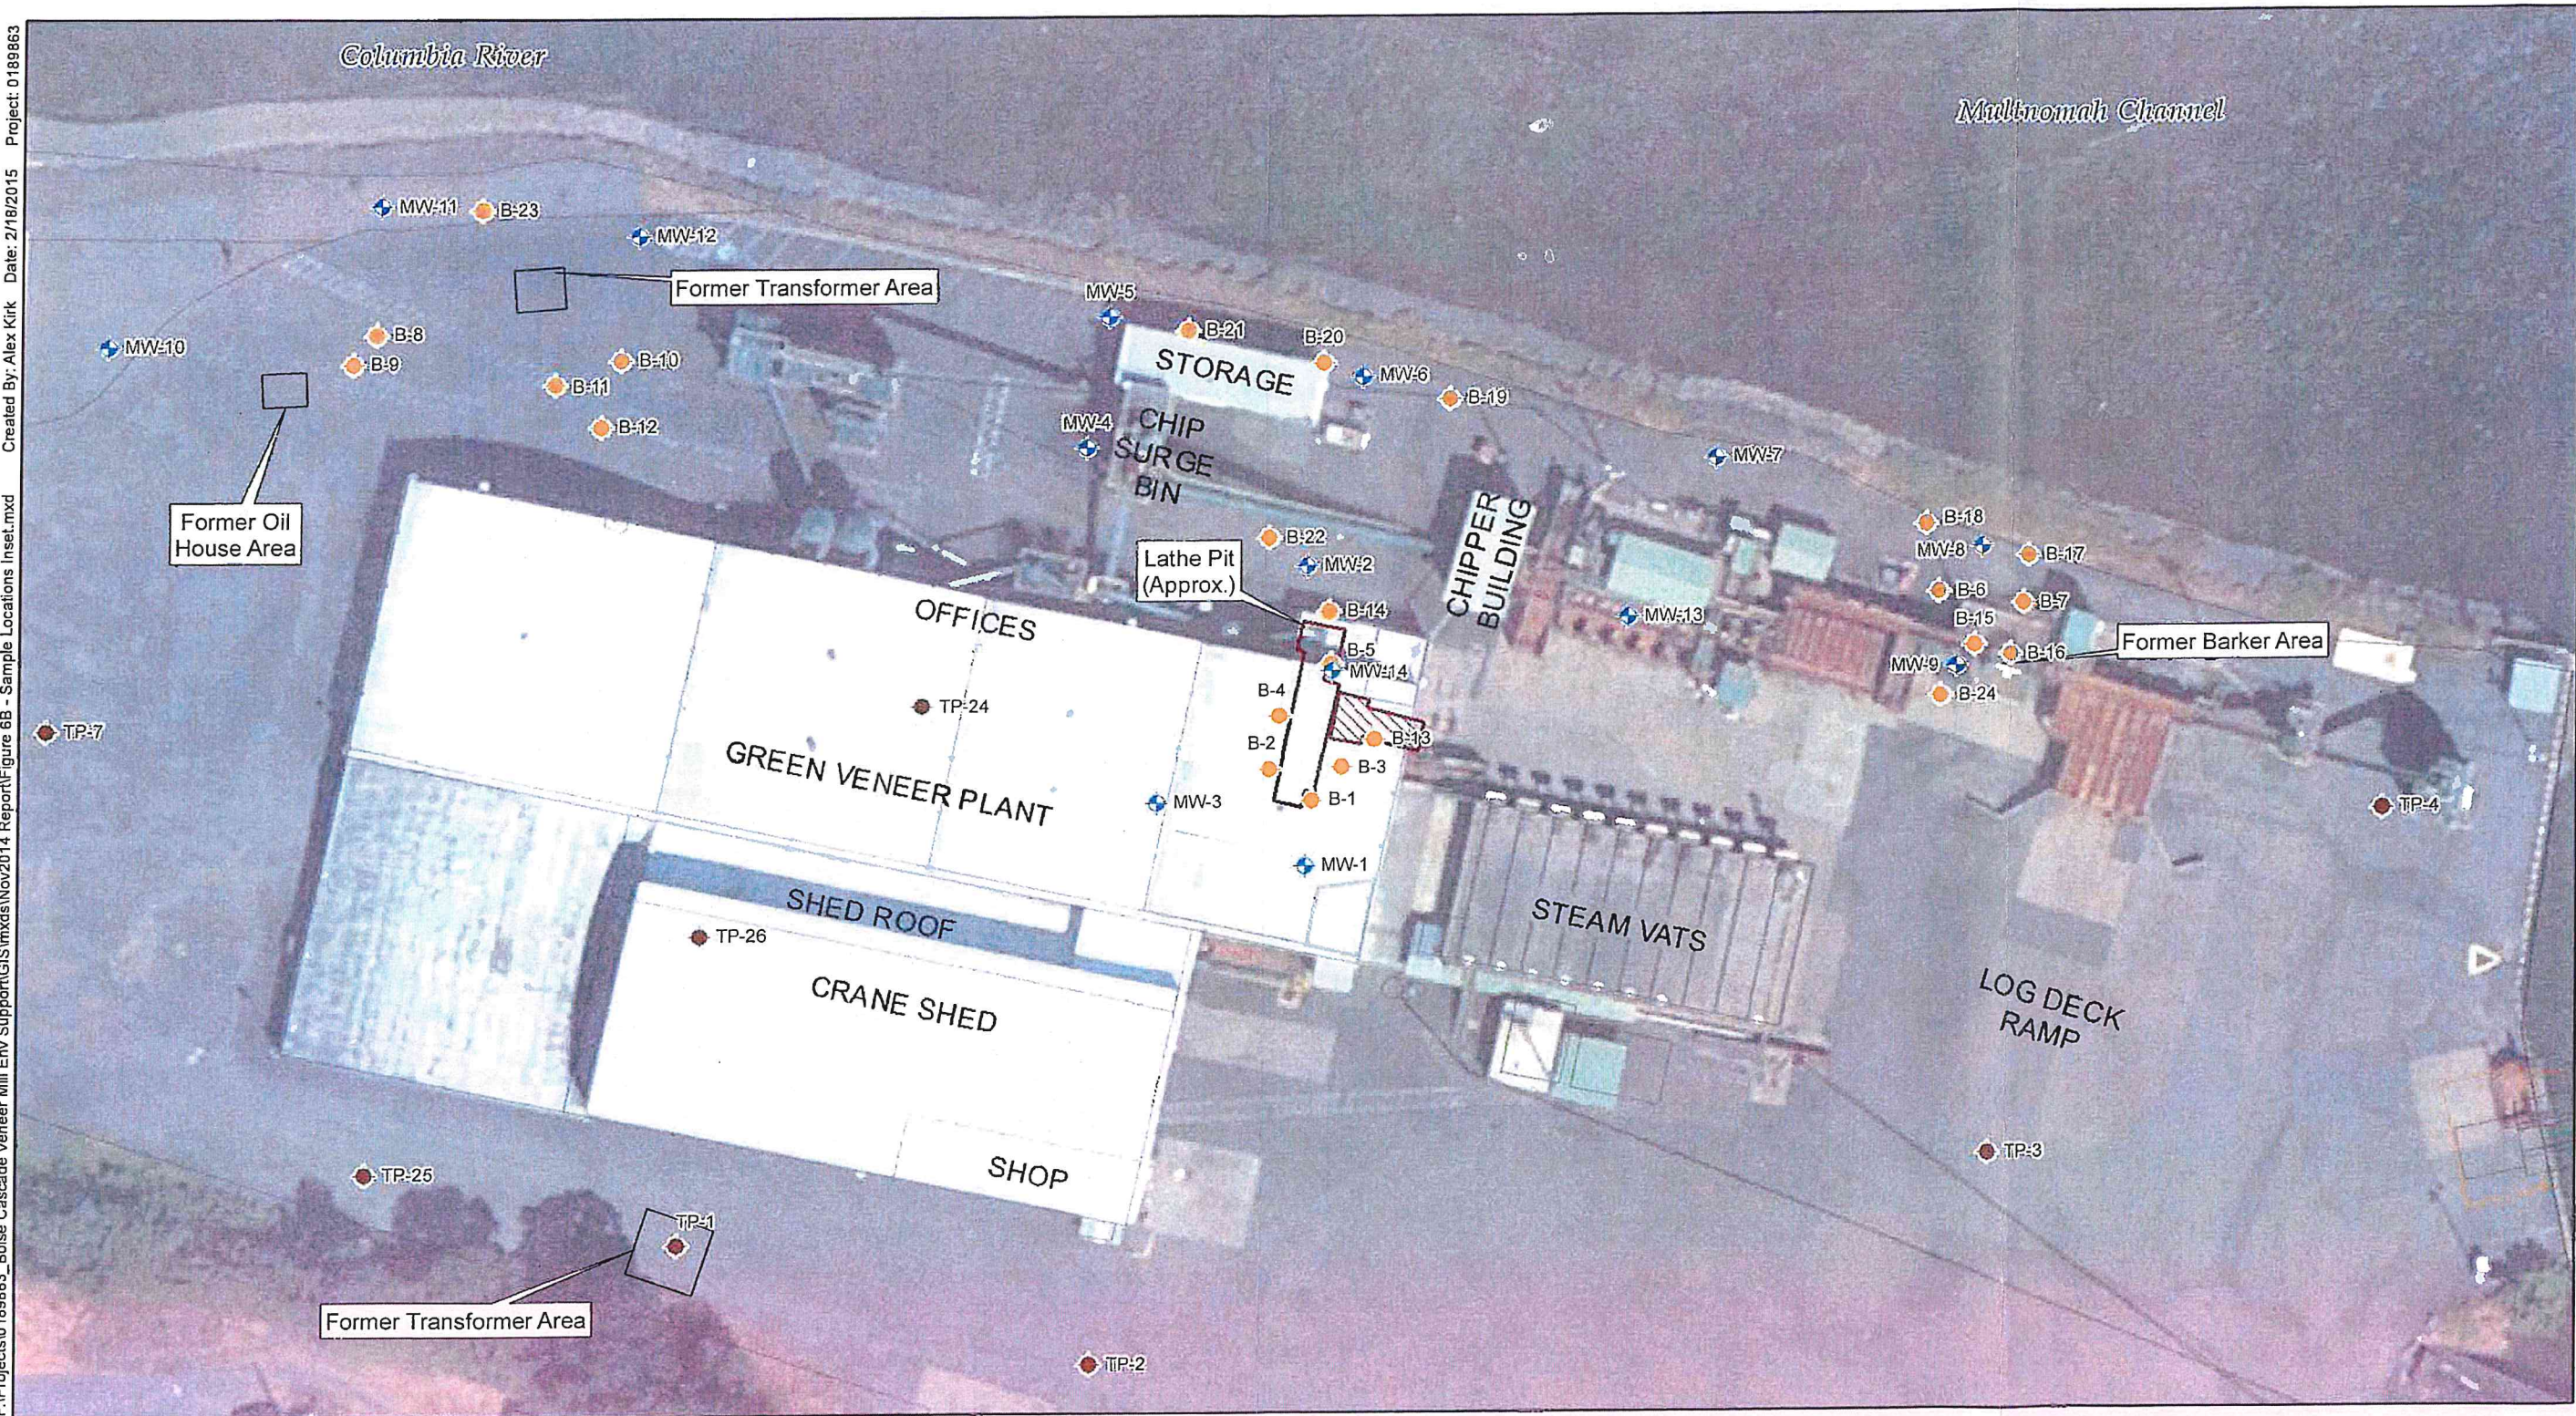
**Figure 6B**  
Borehole, Test Pits, and Monitoring Well Locations Inset  
St. Helens Veneer Mill  
St. Helens, Oregon

- Monitoring Well
- Borehole (ERM)
- Borehole (Maul Foster)
- Test Pit
- Lathe Pit Boundary (Approximate)
- 2001 Lathe Soil Excavation
