St. Helens Riverwalk
Stormwater Drainage Report
Final Revised

City of St. Helens
265 Strand Street
St. Helens, OR 97051

January 24, 2024

Otak, Inc.
808 SW Third Avenue, Suite 800
Portland, OR 97204

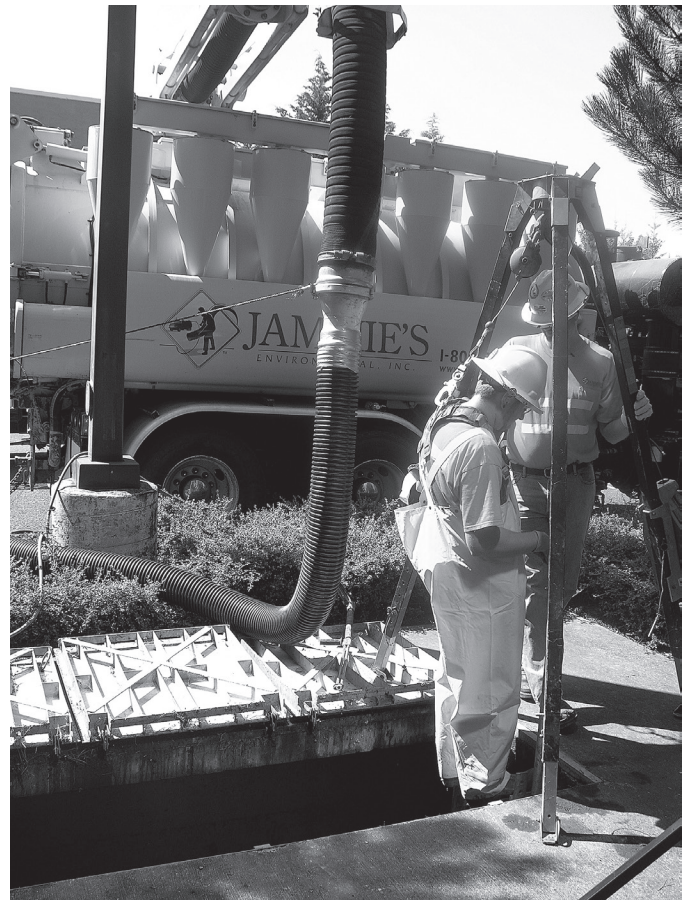
Using appropriate hoisting equipment, attach a cable from the boom, crane, or tripod to the loose cartridge. Contact Contech Engineered Solutions for suggested attachment devices.

- B. Remove the used cartridges (up to 250 lbs. each) from the vault.

Important: Care must be used to avoid damaging the cartridges during removal and installation. The cost of repairing components damaged during maintenance will be the responsibility of the owner.
